**DEPARTMENT OF TRANSPORTATION****DIVISION OF ENGINEERING SERVICES**

Contract #: 04-0120F4Cty: SF/ALA Rte: 80 PM: 13.2/13.9File #: 1.28**WELDING INSPECTION REPORT****Resident Engineer:**Pursell, Gary**Address:** 333 Burma Road**City:** Oakland, CA 94607**Report No:** WIR-016544**Date Inspected:** 27-Aug-2010**Project Name:** SAS Superstructure**OSM Arrival Time:** 800**Prime Contractor:** American Bridge/Fluor Enterprises, a JV**OSM Departure Time:** 1630**Contractor:** American Bridge/Fluor Enterprises, a JV**Location:** Job Site

# WELDING INSPECTION REPORT

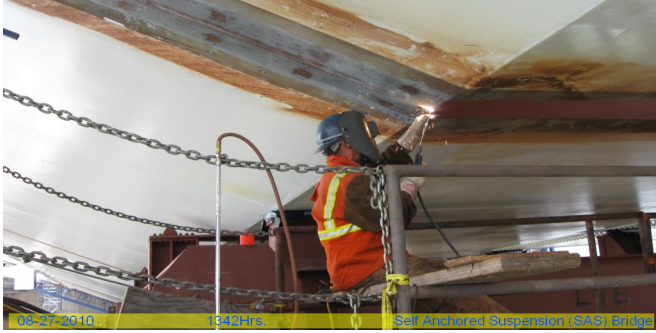
At OBG 4E/5E side plate 'C' outside, ABF welder Rick Clayborn was observed performing welding repair on the welded splice butt joint. Welder was using Shielded metal Arc Welding (SMAW) with 1/8" diameter E7018H4R electrode.

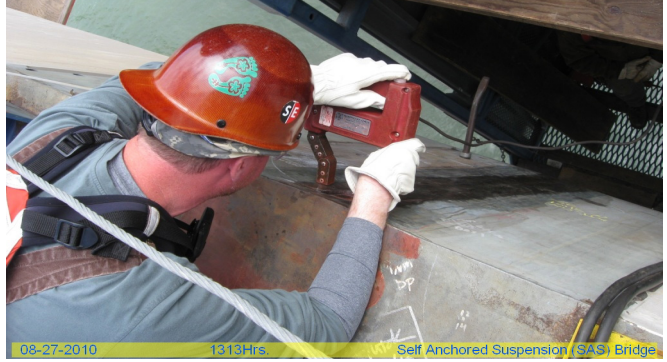
At OBG 5E/6E side plate 'B' outside, ABF QC Steven Mc Connell was observed performing Magnetic Particle Testing (MT) on the repair excavation prior welding.
